| | | DEPARTMENT OF | ARKS AND RECREATION | HABSUTM: A .<br>C . | HAER | Ser. No. | B | SHL<br>3609440 | Loc |
|---|---|---|---|---|---|---|---|---|---|
| IDE | NTIF | Common name: | Barbara McCann Hous | se | | | | | A.L |
| | 2. | Historic name: | Claude Conklin Hous | | | | | | |
| | 3. | Street or rural ad | dress: 877 Country Clu | 1b Drive | 11 | 191 | San | Diego | |

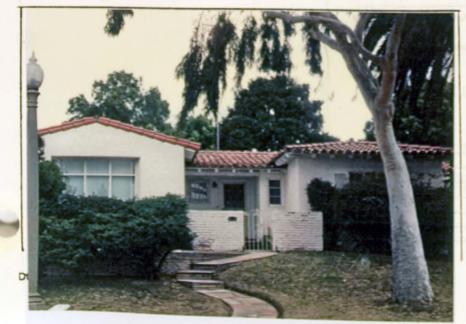
Legal: Country Club Villas, Blk D, Lot 8 This large, one story, stucco house stands on a corner lot. The home features a complex, cross gable and shed, red tile roof with exposed rafter ends. At the front, the building is almost "U" shaped with a small entrance courtyard inside the "U" and partly enclosed by a low wall. A high wall extends from the left side of the house and curves around the corner to meet an attached garage which faces a side street. The wall supports a red tile shed roof that apparently slopes to the rear to shelter an open porch. The garage has a street-facing overhead door. Some windows in the house are large, fixed, and inset; others are casements. A few have shutters. Two large chimneys are incorporated into exterior walls. The vertical wooden siding, visible on the house wall next to the entrance courtyard appears to be an alteration.

| 13. | Condition: Excellent X_Good Fair Deteriorated No longer in existence |
|---|---|
| | Alterations: wooden siding near entrance |
