HISTORIC RESOURCES INVENTORY

- IDENTIFICATION
1. Common name: Dermot McDermott House
2. Historic name: Elmer Stewart House
3. Street or rural address: 238 Del Mar Avenue
City Chula Vista Zip 92010 County San Diego
4. Parcel number: 568-072-12
5. Present Owner: Dermot W & Maria J McDermott Address: 238 Del Mar Avenue
City Chula Vista Zip 92010 Ownership is: Public _____ Private X
6. Present Use: residential Original use: residential

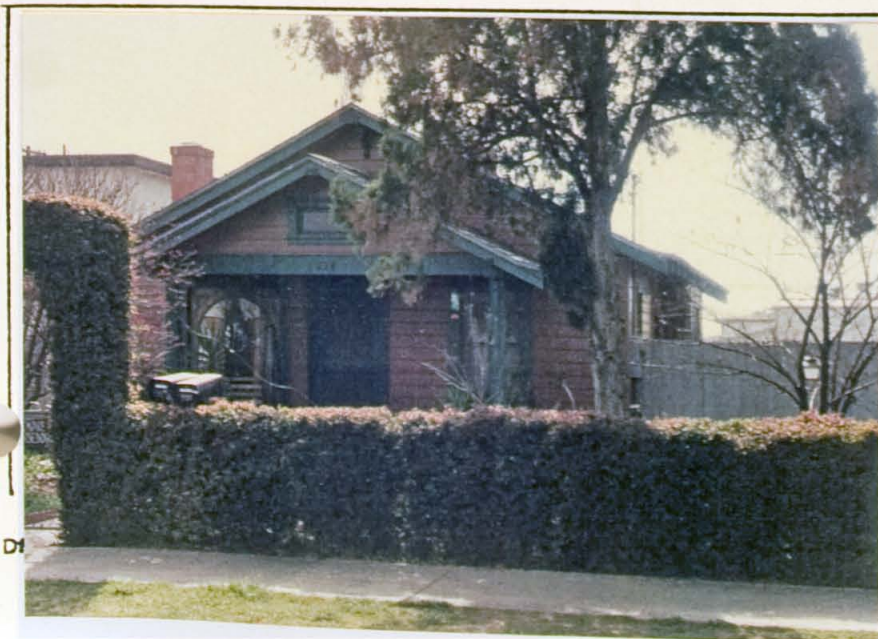
Dense foliage obscures the view from the street of this charming and rustic bungalow. The one story house features a medium, front-facing gable roof with wide eaves, carved brackets, visible support beam ends, and carved, exposed rafter ends. An open porch at the front center has a matching, but lower, gable roof, slightly flared at the eaves. At least two columns support the porch roof. Two special details appear on the left side of the house: an exterior brick chimney and an angled bay window. The home has shiplap siding and may have a room addition at the rear.
