HISTORIC RESOURCES INVENTORY

1. Common name: Kathleen Allen House
2. Historic name: Frances Norman House
3. Street or rural address: 337 Del Mar Avenue
- City Chula Vista Zip 92010 County San Diego
4. Parcel number: 568-331-15
5. Present Owner: Kathleen A Allen Address: 337 Del Mar Avenue
- City Chula Vista Zip 92010 Ownership is: Public _____ Private X
6. Present Use: residential Original use: residential

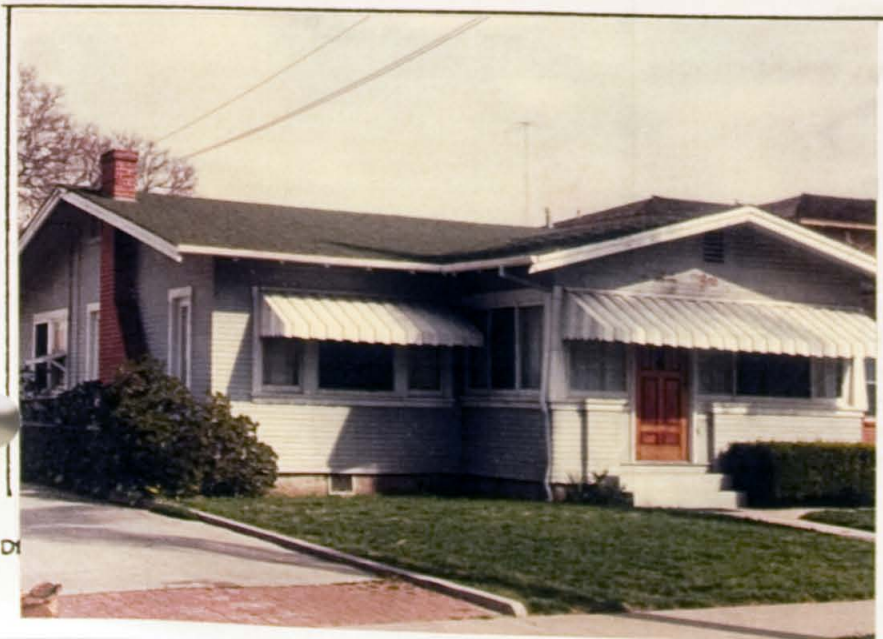
This one story bungalow features a low, cross gable roof with a street-facing gable roof sheltering an enclosed porch. The eaves are wide with exposed rafter ends. The porch has been enclosed with a door and fixed or sliding wooden frame windows. The two original square tapered porch roof supports are visible at each front corner. The home has horizontal clapboard siding flared at the foundation line and laid up to the window sill level on the porch. Other details include louvered vents in the gable ends, double hung windows and an exterior brick chimney on the left side of the house. Metal awnings shade the street-facing windows.

13. Condition: Excellent ___ Good Fair ___ Deteriorated ___ No longer in existence ___
14. Alterations: metal awnings
15. Surroundings: (Check more than one if necessary) Open land ___ Scattered buildings ___ Densely built-up
Residential Industrial ___ Commercial ___ Other: _____
16. Threats to site: None known Private development ___ Zoning ___ Vandalism ___
Public Works project ___ Other: _____
17. Is the structure: On its original site? Moved? ___ Unknown? ___
18. Related features: garage, shrubs
