HISTORIC RESOURCES INVENTORY

1. Common name: Henry Diaz House
2. Historic name: Florence Harkins House
3. Street or rural address: 639 Del Mar Avenue
City Chula Vista Zip 92010 County San Diego
4. Parcel number: 573-180-09
5. Present Owner: Henry J & Mary C Diaz Address: 639 Del Mar Avenue
City Chula Vista Zip 92010 Ownership is: Public _____ Private X
6. Present Use: residential Original use: residential

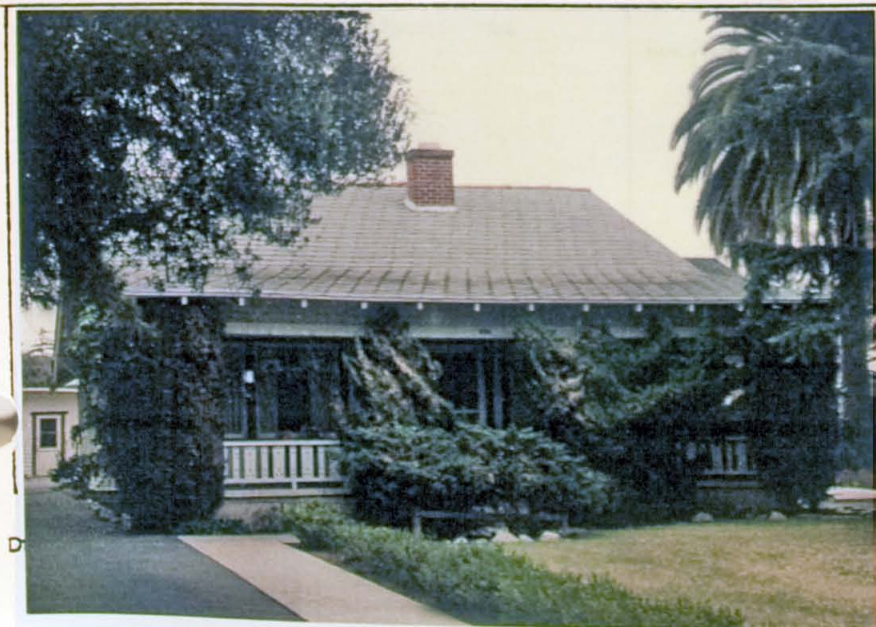
This one story house features a medium, side-facing gable roof with a shed extension in front to shelter an open porch. The eaves are wide, rafter ends exposed, and a brick chimney pierces the roof near the ridge line. The home is nearly symmetrical with an entrance at the center flanked by windows on each side. A square post on a pier supports the porch roof at each front corner. Two piers without posts near the center balance the design. The porch, which extends completely across the front, has an interesting railing with perforated slats much like those seen on Eastlake homes. Windows in this house are generally double hung. The home has horizontal clapboard siding flared at the foundation line. An addition has been added to the right end of the house and has board and batten siding as well as aluminum frame windows.
